4260 El Camino Real - No Glare Problems From Siding

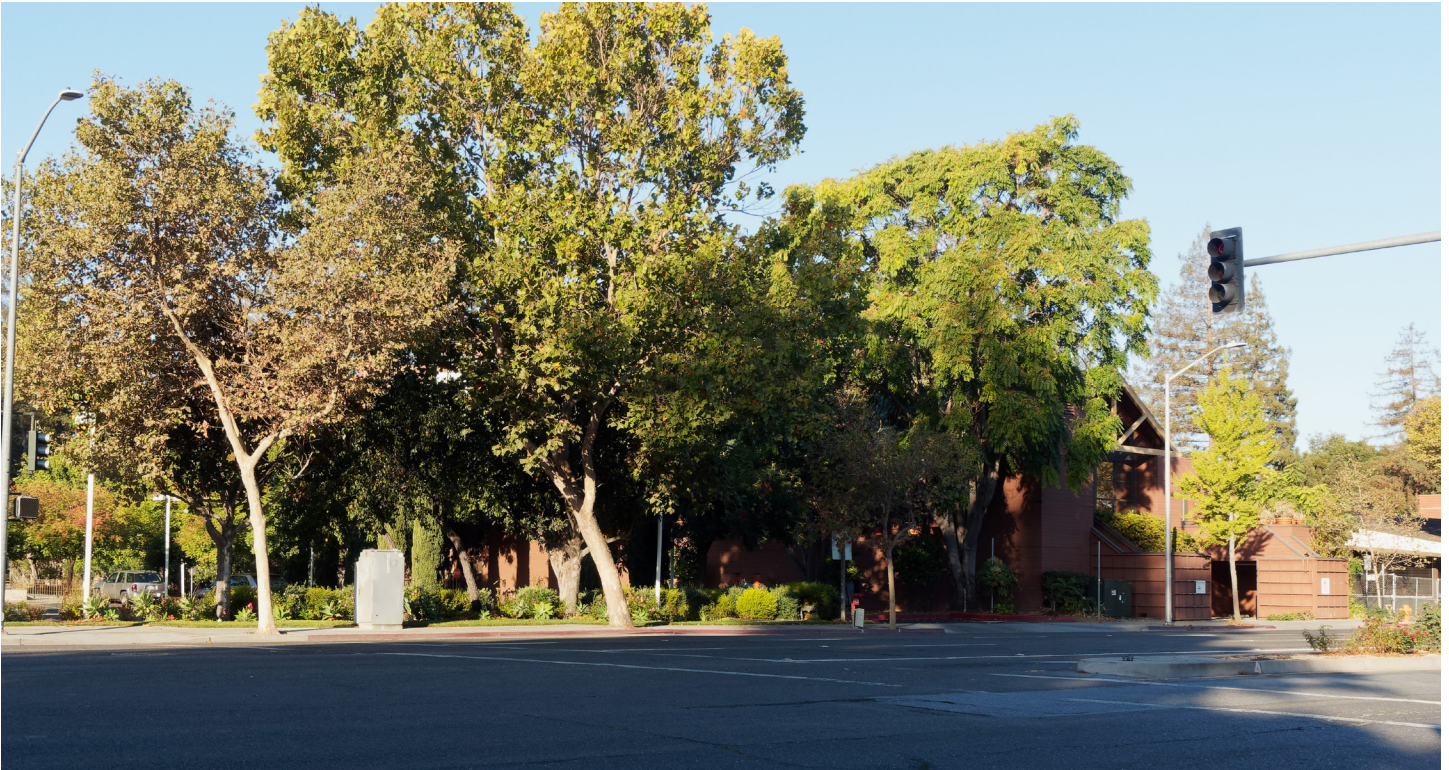
The picture below shows 4260 El Camino Real from the angle of the morning sun (notice the shadow of the light pole falls almost directly behind it on the stairway).

As can be seen from the picture, even a highly reflective surface on the left side of the building would not create glare. The left side of the building is very heavily shaded by trees. Furthermore, if there were any reflected light, it would go into the large Crowne Plaza parking lot. The sun does not shine on this side of the building in the afternoon.

The front of the building is nearly entirely covered by windows, the garage gate, and the stairways. There is very little siding to reflect light. The stairway siding is not going to be metal panels. The small amount of metal siding on the front is set back from the street and is not visible from El Camino Real until the viewer is almost directly in front of the building. Even a very reflective surface would not create a glare problem.

The right side of the building is on the opposite side from the morning sun and thus in shade until afternoon. The new 5-story hotel is going to be 10 feet from 4260 El Camino Real and will be built closer to the sidewalk than 4260 El Camino Real, leaving a dark alleyway between the two buildings. Afternoon sun will not reach the right side. The right side of 4260 El Camino Real will not be visible to traffic. Even if the hotel isn't next door, since the afternoon sun is coming towards the right rear corner of 4260 El Camino Real, any light striking the right side could only be reflected across El Camino Real and not into the eyes of people traveling on El Camino Real. The sun would have to be coming from the north to be reflected towards traffic on El Camino Real.

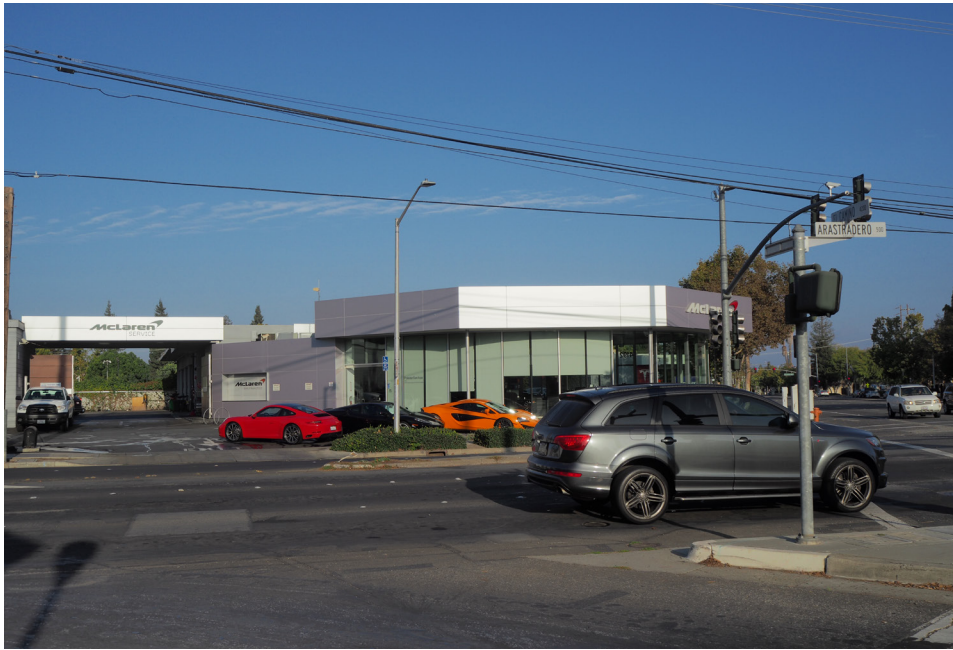
The picture above shows the worst possible reflected light from the McLaren building. The reflected light is no worse than a white surface. It is also not reflected towards El Camino Real. 4260 El Camino Real is oriented so that any reflected light would be even further away from El Camino Real, but the trees along the side of 4260 El Camino Real block light from even shining on the side of the building.

Both the McLaren building and the Volvo building have silver metallic panels, have a roughly similar orientation as 4260 El Camino Real, and do not create a glare problem even though they do not have the tree cover which 4260 El Camino Real has.
